## Report

### An Investigation into the Handlebar Failure that Occurred in the Australian Men's Team Pursuit race at the Tokyo 2020 Olympics

Date of Incident: 2<sup>nd</sup> August 2021

Location: Izu Velodrome, Tokyo, Japan

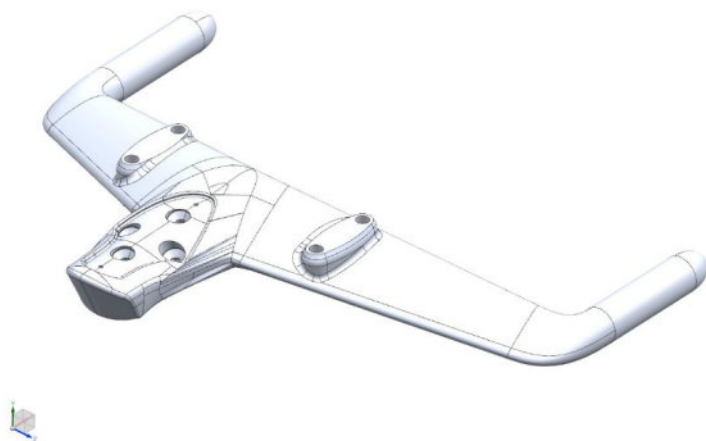
Figure 3: Argon 18 Base Bar with 35mm Extension

30. Prima facie, the extension was geometric to obviate a human to Base Bar conflict but from a structural perspective, the site of the extension and the flare into the wings of the Base Bar changed its stiffness and consequently its fatigue performance. This changed fatigue performance, constrained by the Specification Computer Aided Design drawing, was a factor in the failure.

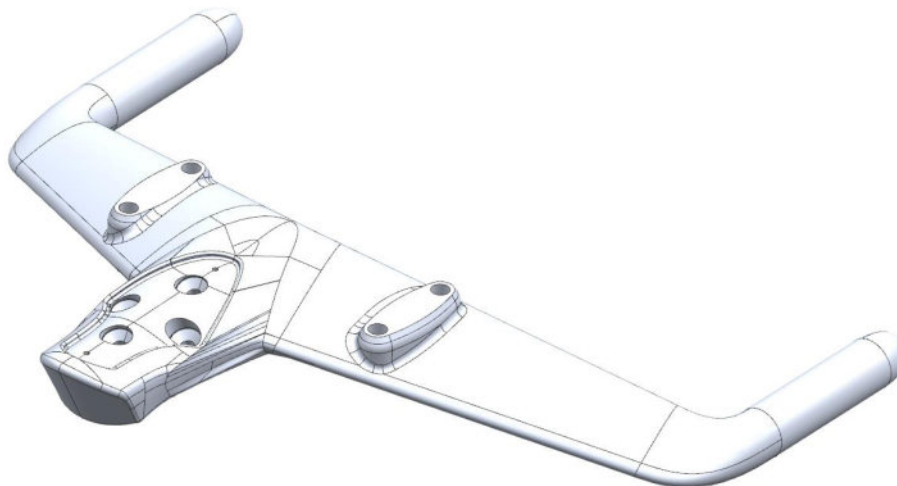
*Figure 5: Computer Aided Design skin with 35mm extension as Specified*

42. The Australian Cycling Teams Specification comprised a Computer Aided Design skin-only drawing and a test requirement: the skin drawing only specified a printed surface where the Base Bar mated with the machined aluminium surface on the top of the steering forks. Previously supplied Bastion Head Stems which mated to the steering fork were provided with a printed-only mating surface without any reported or documented mismatch.

47. The Specification for the design was inadequate and based only on a Computer Aided Design skin drawing modified to include a 35mm extension. Specifically, the Base Bar to steering fork mating surface was not required to be machined, nor was a tolerance stated.

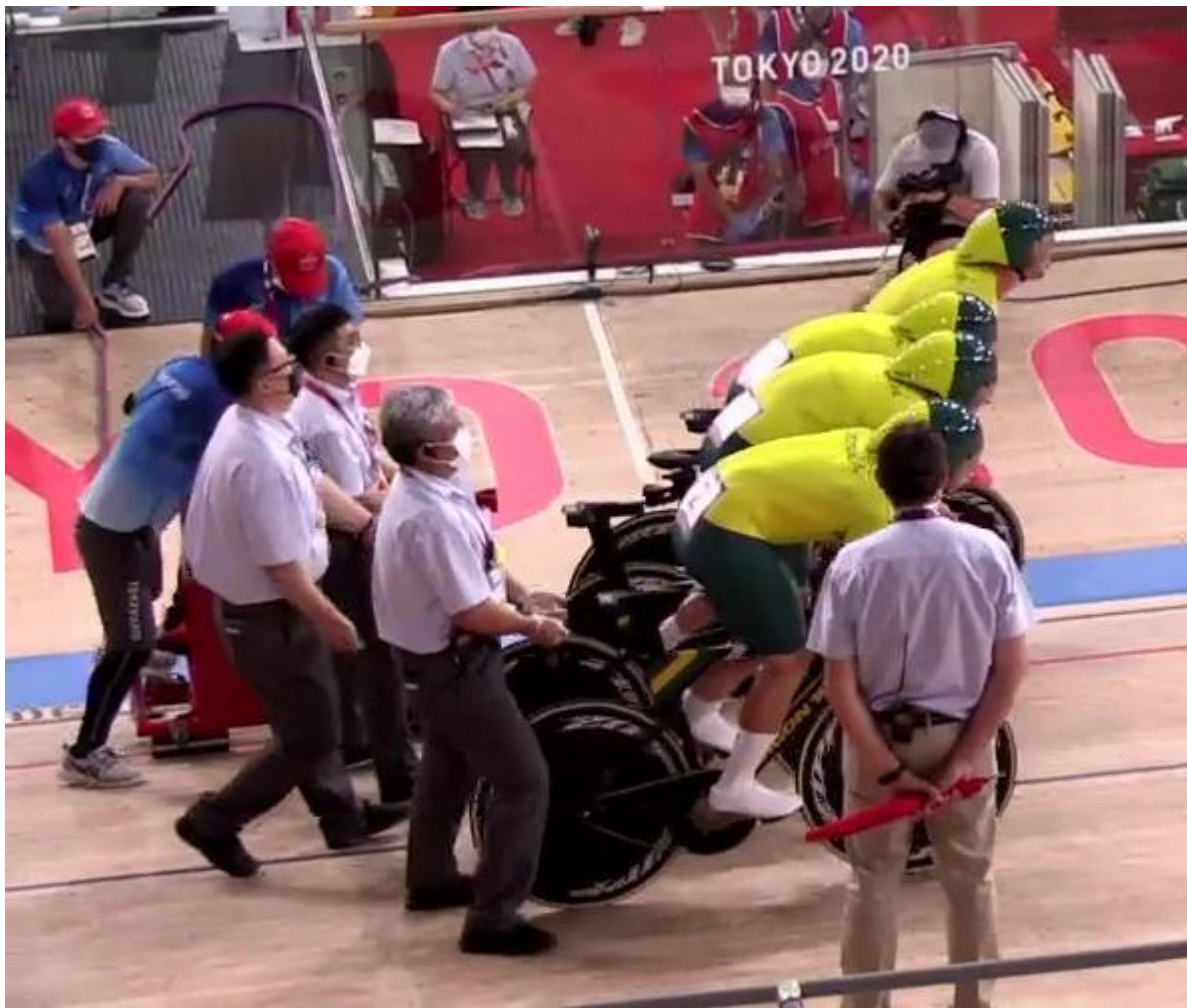
Figure 7: Athlete rider on start release, Tokyo 2020

59. In use, the most severe forces applied to the Base Bar occurred immediately after the release at the start of a race. The starting position shows the athlete rider standing, rider weight forward over pedals, leveraging upwards on the Base Bar to achieve the maximum pedal force with pedal torque forces recorded on the infocrank system. As the Base Bar was used by many athlete riders, this starting torque was repeated and at varying values. Appendix B, Figure 33 of the Bastion Base Bar Failure Investigation Data Collection gives a clockwise torque of 410Nm from the left pedal and an additive clockwise torque of 95Nm from the right pedal at start: subtracting the upwards force on the one pedal from the downwards force on the other pedal results in a downward force which, less the rider's weight, must be balanced by an upward force on the Base Bar.

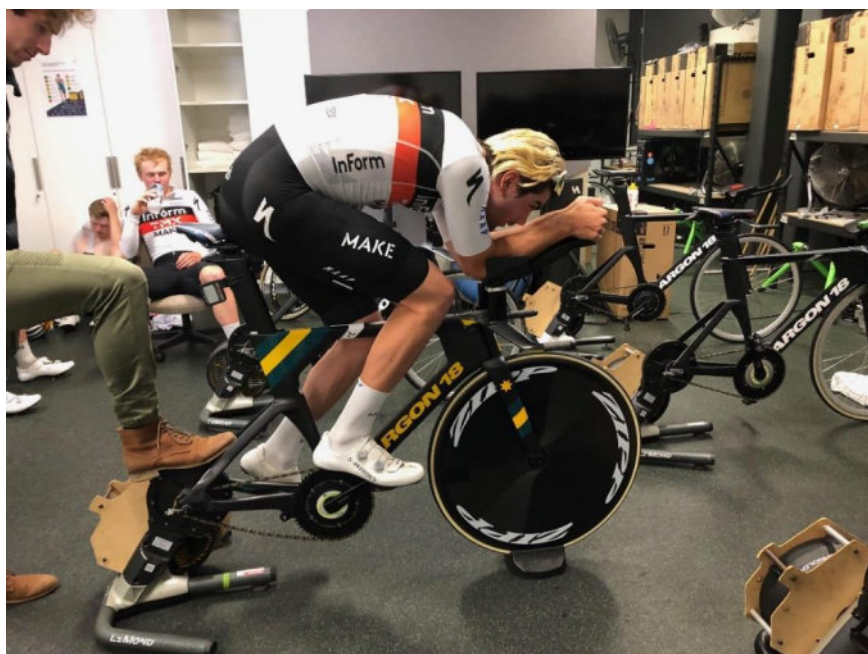
Figure 8: Isometric Exercise Riding Position

65. **Isometric Exercises.** Athlete riders complete isometric exercise to prepare their muscles for maximum effort, all at a particular joint angle; when on training camps and at the 2020 Tokyo Olympics, these exercises were completed on the racing frames and the Coach estimated some 324 repetitions for all four Base Bars. The force at the Base Bar to be reacted by the mass of the athlete rider, the seat and the muscle-to-pedal force was extracted by the Australian Cycling Team (Annex I). On examination, the value extracted was found to be in error, in that not all of the contributions to a rigid body equilibrium had been included. The error was traced to inadequate process and checking.

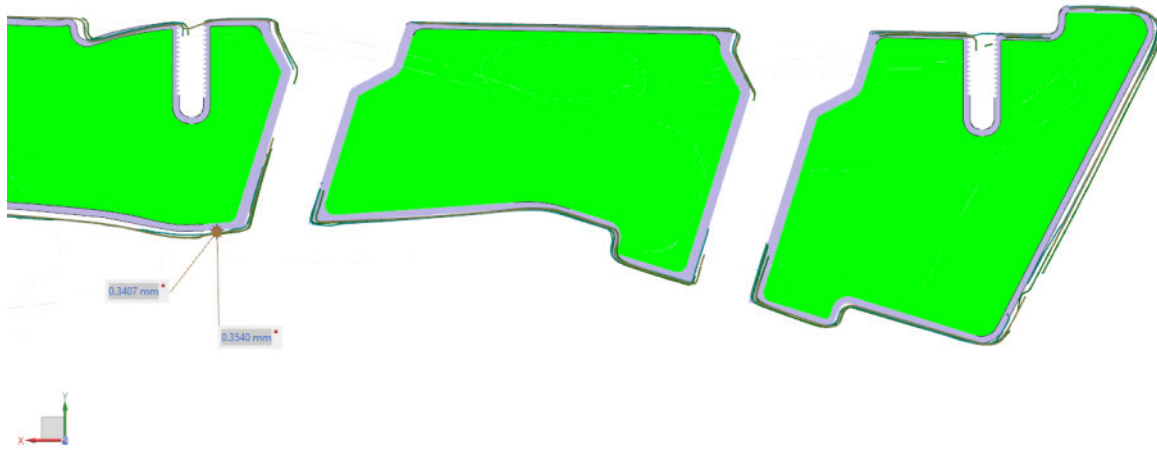
Figure 12: Base Bar Longitudinal Centre Line Section

81. The .29mm elevated area with respect to the remainder of the Base Bar to steering fork mating surface would place the Base Bar material at that point in compression. From science, cracks do not grow in compression however, the Base Bar is a thin skin component and whilst the external skin would be compressed the corresponding inside surface would be in tension and exposed to a change of geometry, a change of stiffness and elevated stress from the excess force applied to the Base Bar.

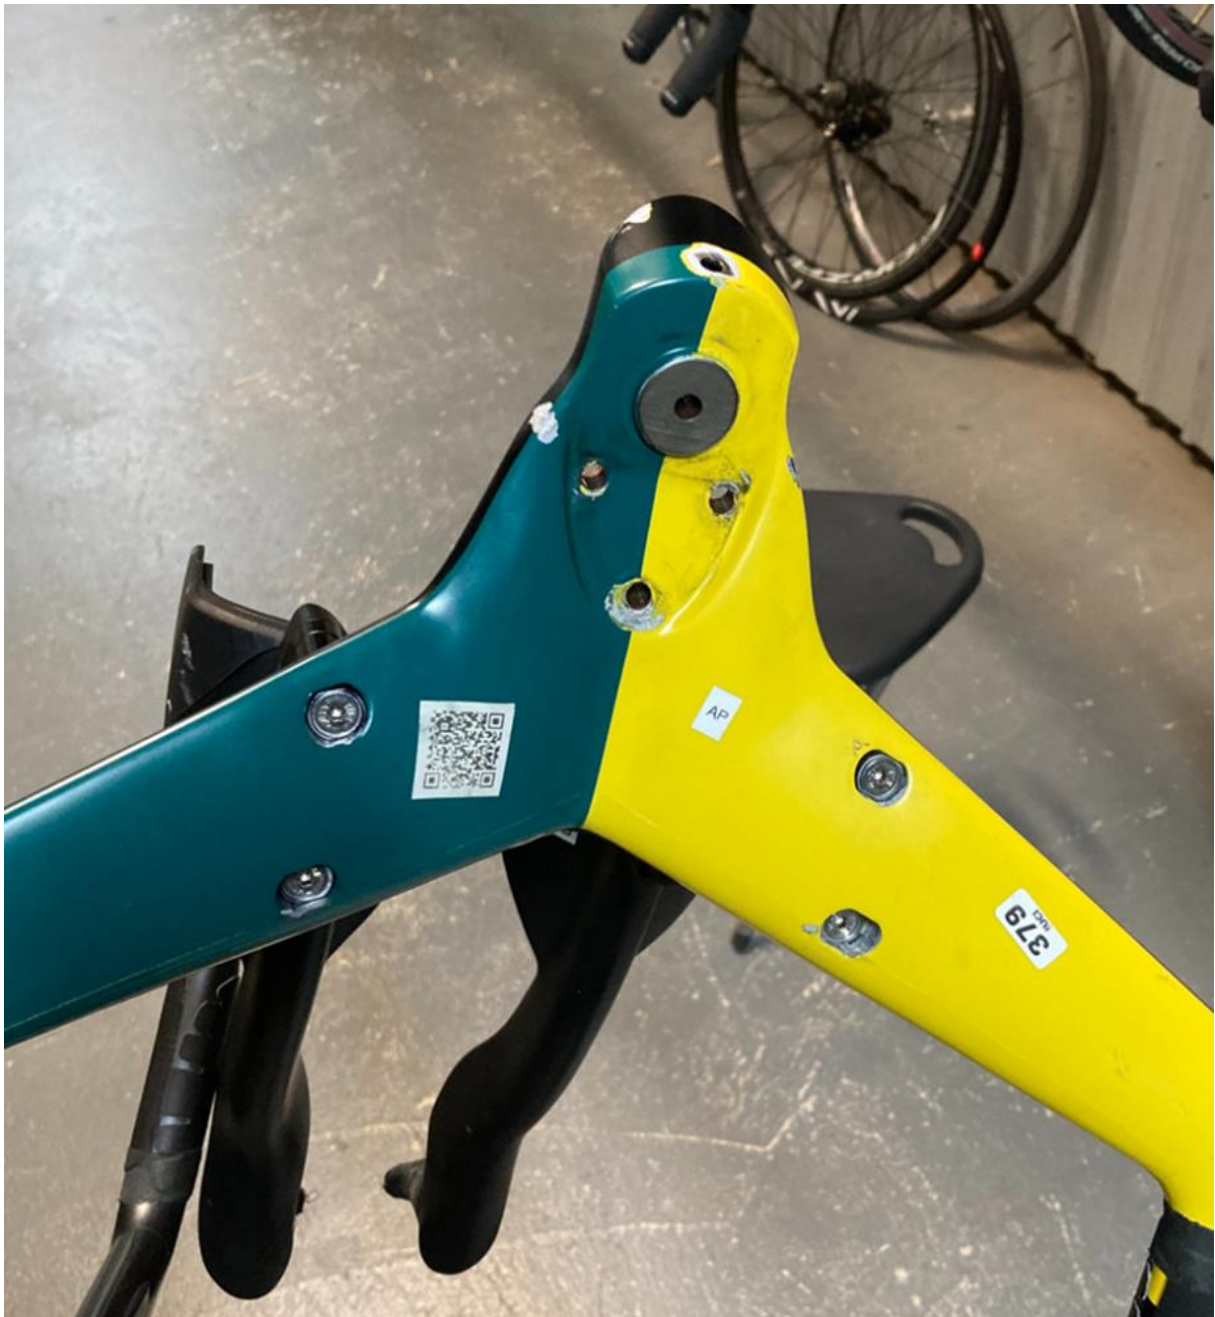
84. When the Number one Base Bar was painted, the under-surface cover was complete including the Base Bar to steering fork mating surface. Annex L was the paint plan used. Base Bars Two, Three and Four were painted differently with no traceability of the relevant paint plans. Significantly, the steering fork mating surface for Base Bars Two, Three and Four were not painted and left as printed. On examination during the investigation, paint forward of the forward bolt hole on the Base Bar One was missing. Complimentary, but less significant is the missing paint around the two lateral holes.

*Figure 14: Number One Base Bar with paint missing from the front bolt hole*

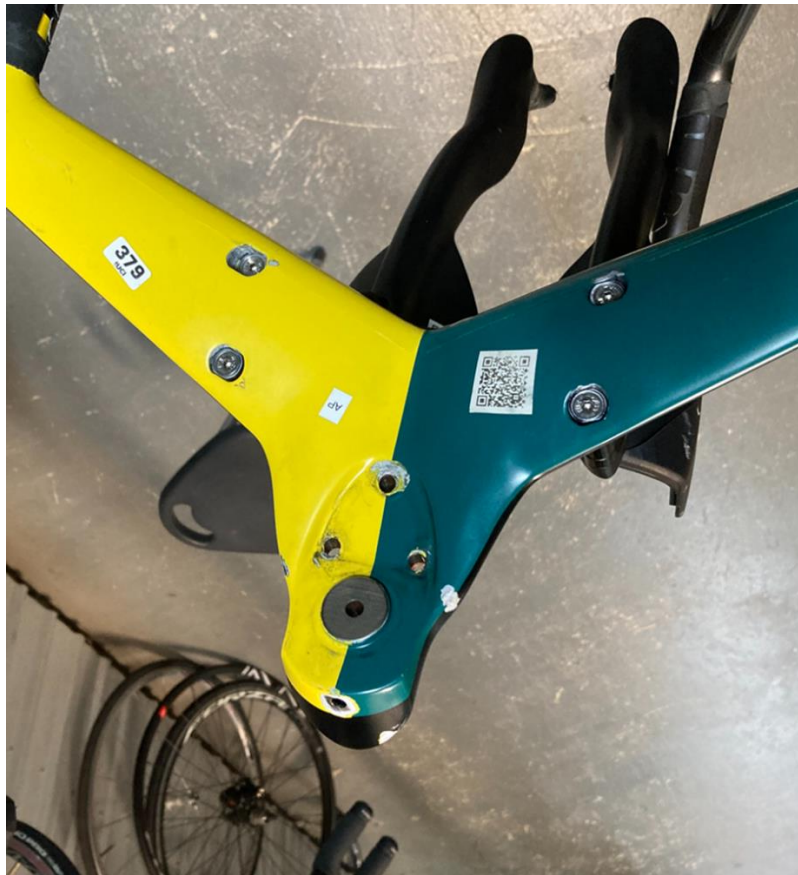
Figure 15: Number One Base Bar under view

89. On receipt of the first Base Bar from Bastion Cycles, an acceptance testing programme was required by the Process for the Introduction of New Componentry [Appendix E], but this acceptance testing was never completed. Base Bar Number one was distinctive in that it was painted mat black on the top and yellow and green underneath.

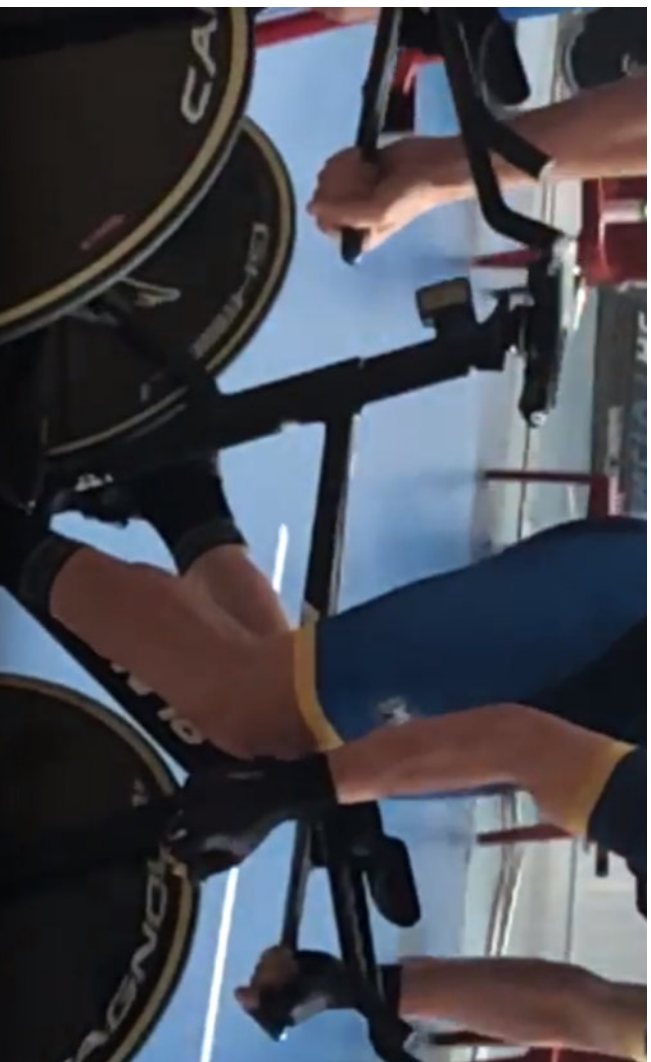
Alex hits the top of knee/front of thigh on the rear edge of the basebar. The hitting causes the front wheel to lift and could cause a fall.

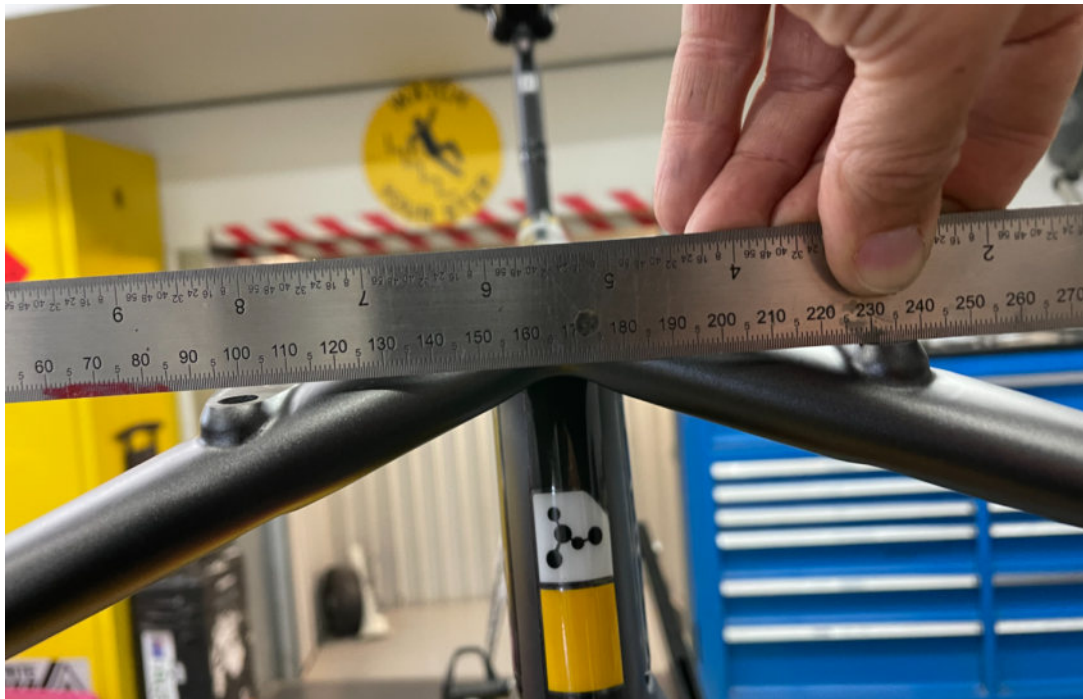
*Figure 7 - Bastion bar #2 extension mounting surface issue*

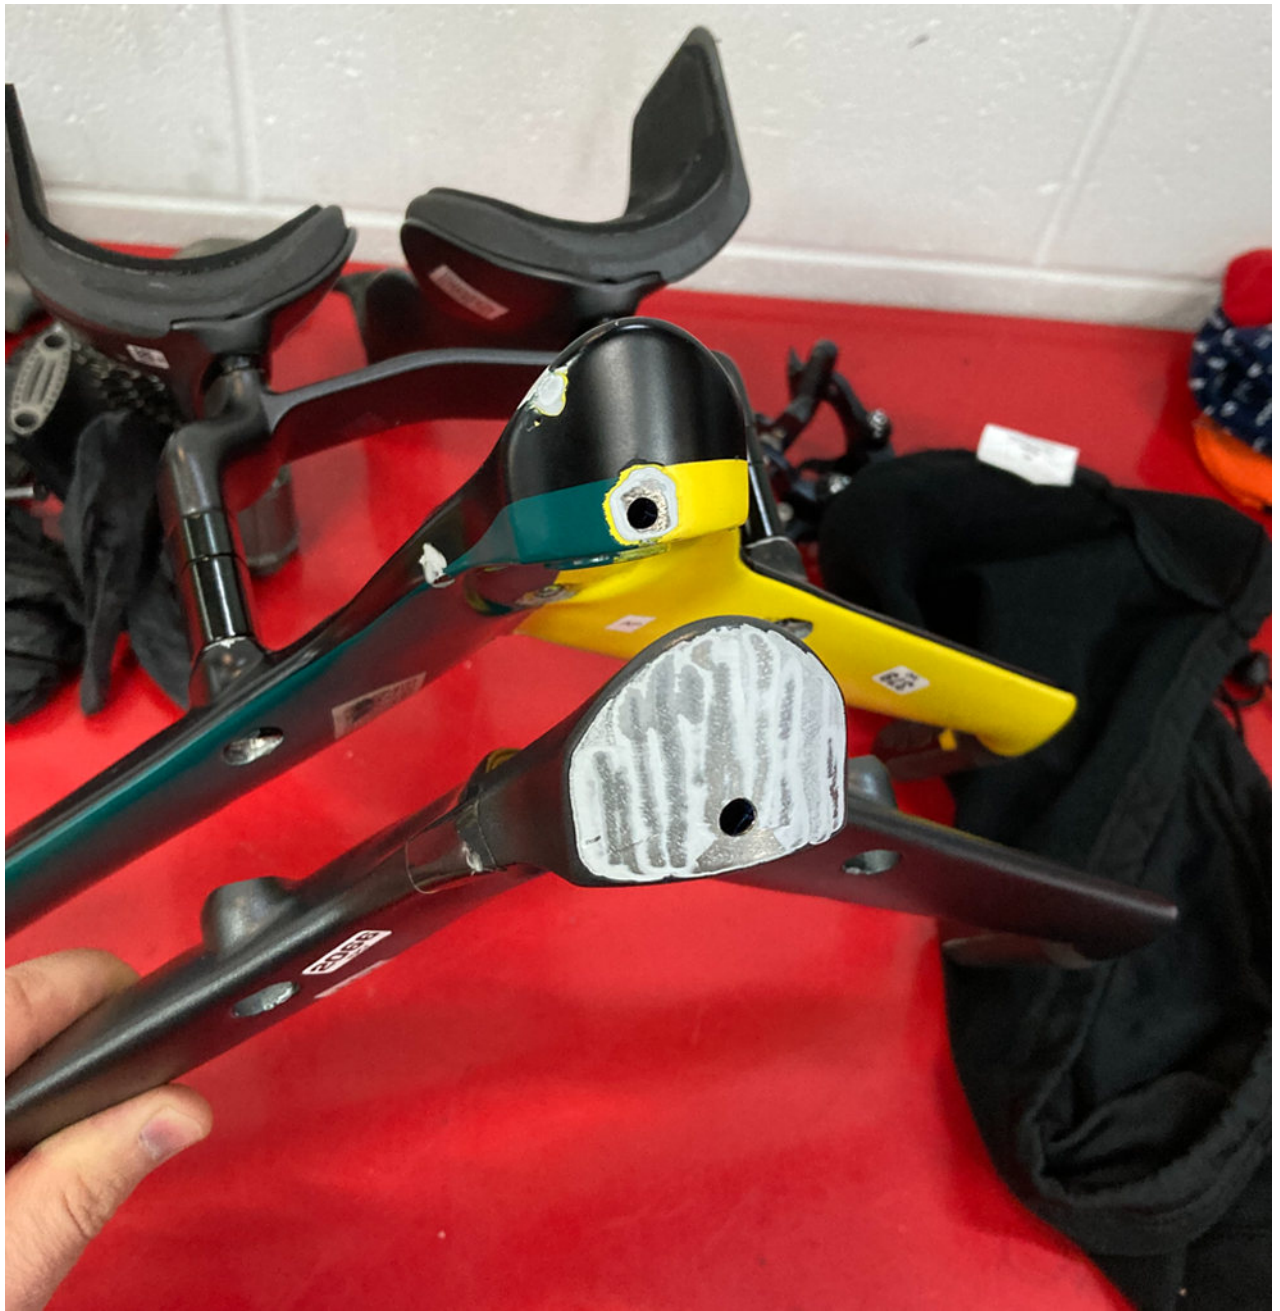
*Figure 9 - Bars #1 (top) and #2 (bottom) showing rear surface, no breather holes. Inspection holes drilled by ACT after Tokyo qualifying incident to confirm oxidisation*

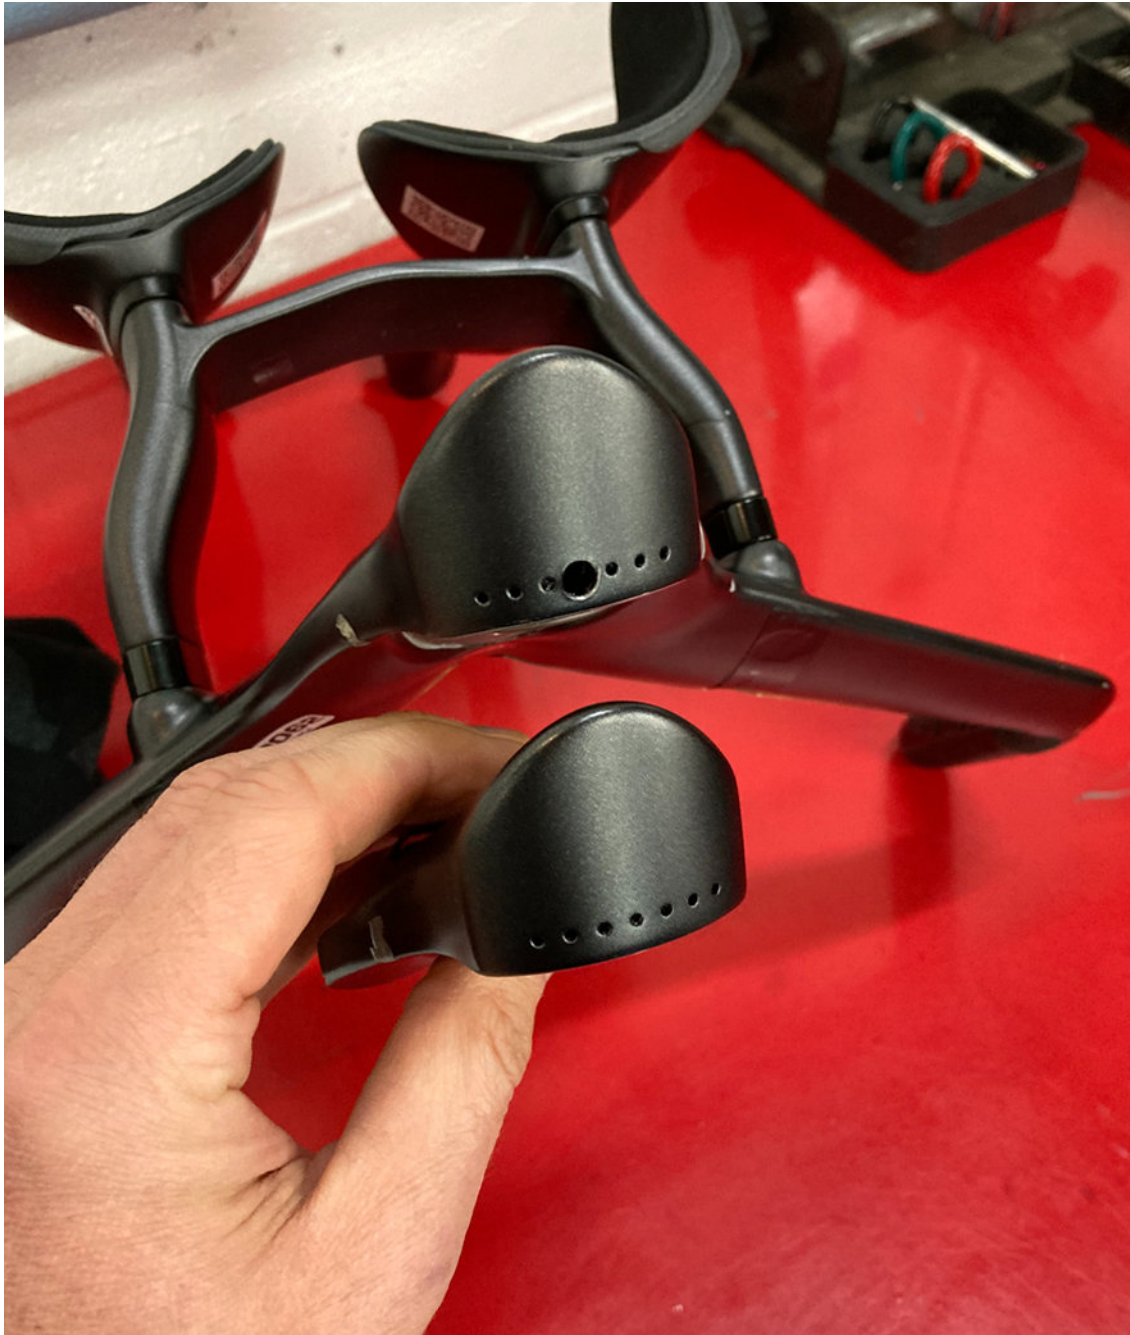
*Figure 10 - Bars #3 (top) and #4 (bottom) showing presence of additional breather holes. Drilled hole in bar #3 by ACT to inspect oxidation. Bar #4 is that which failed under Alex Porter*

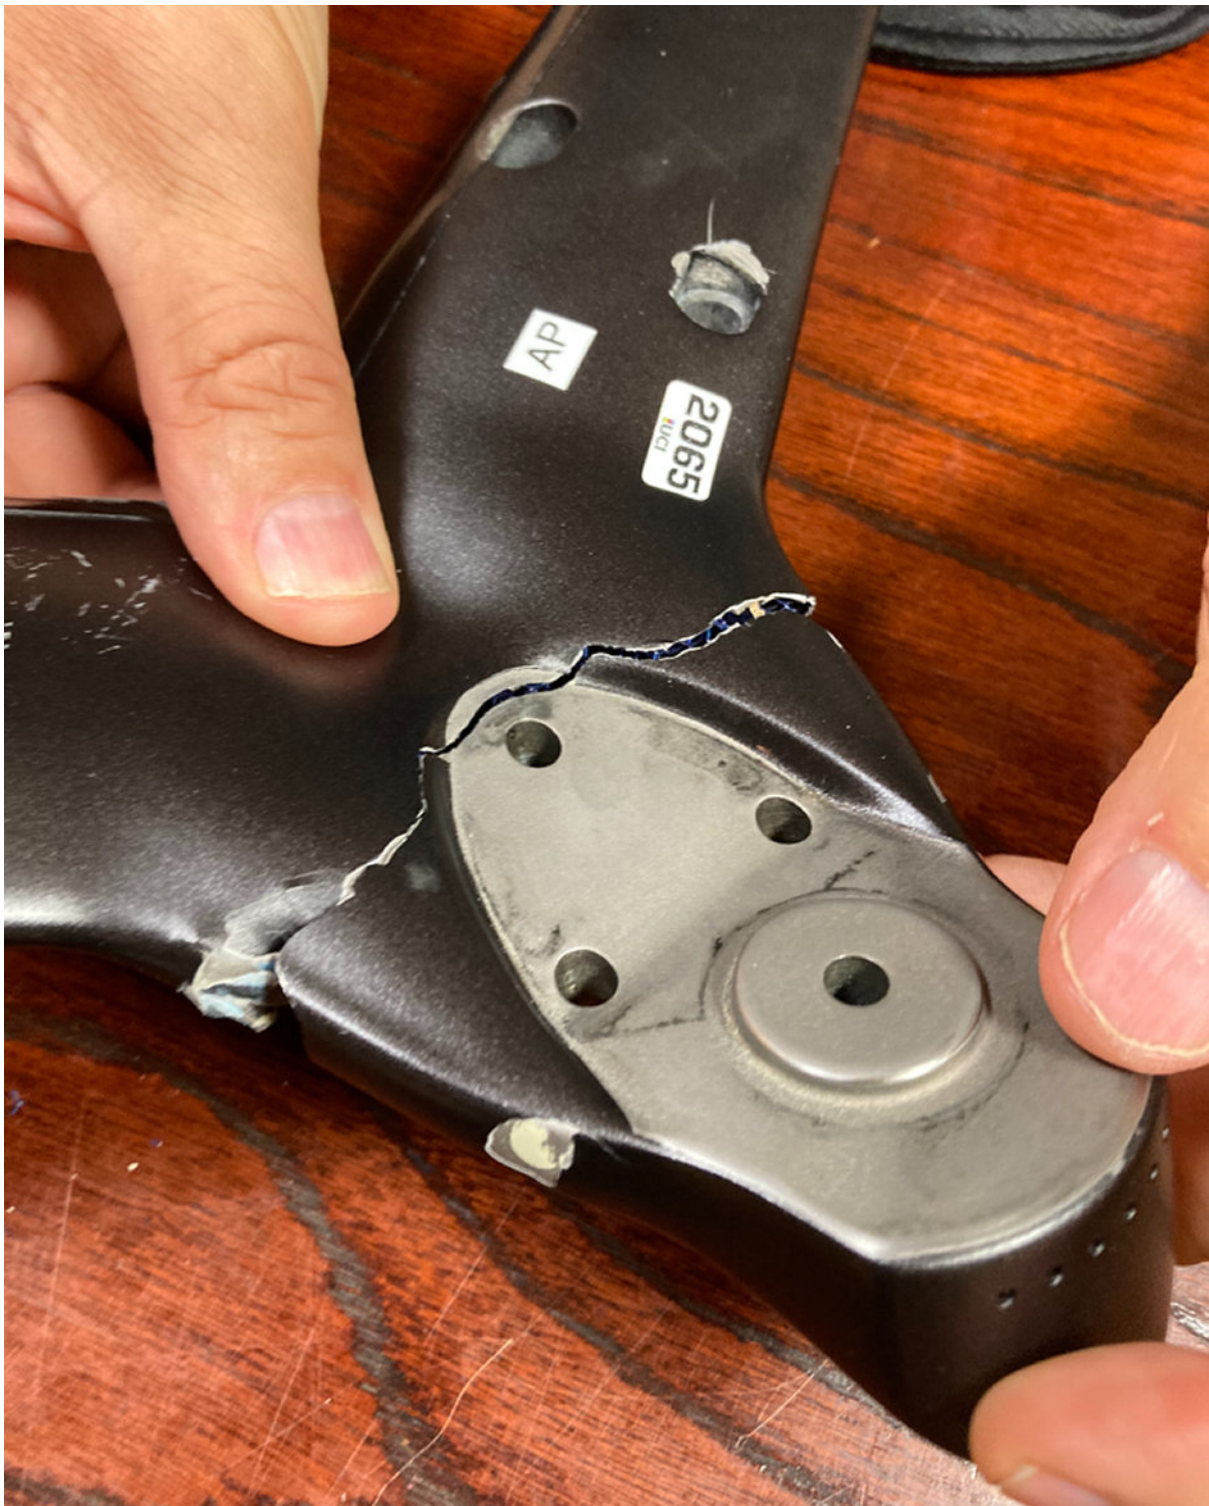
Figure 12 - Bar #4 both parts held together

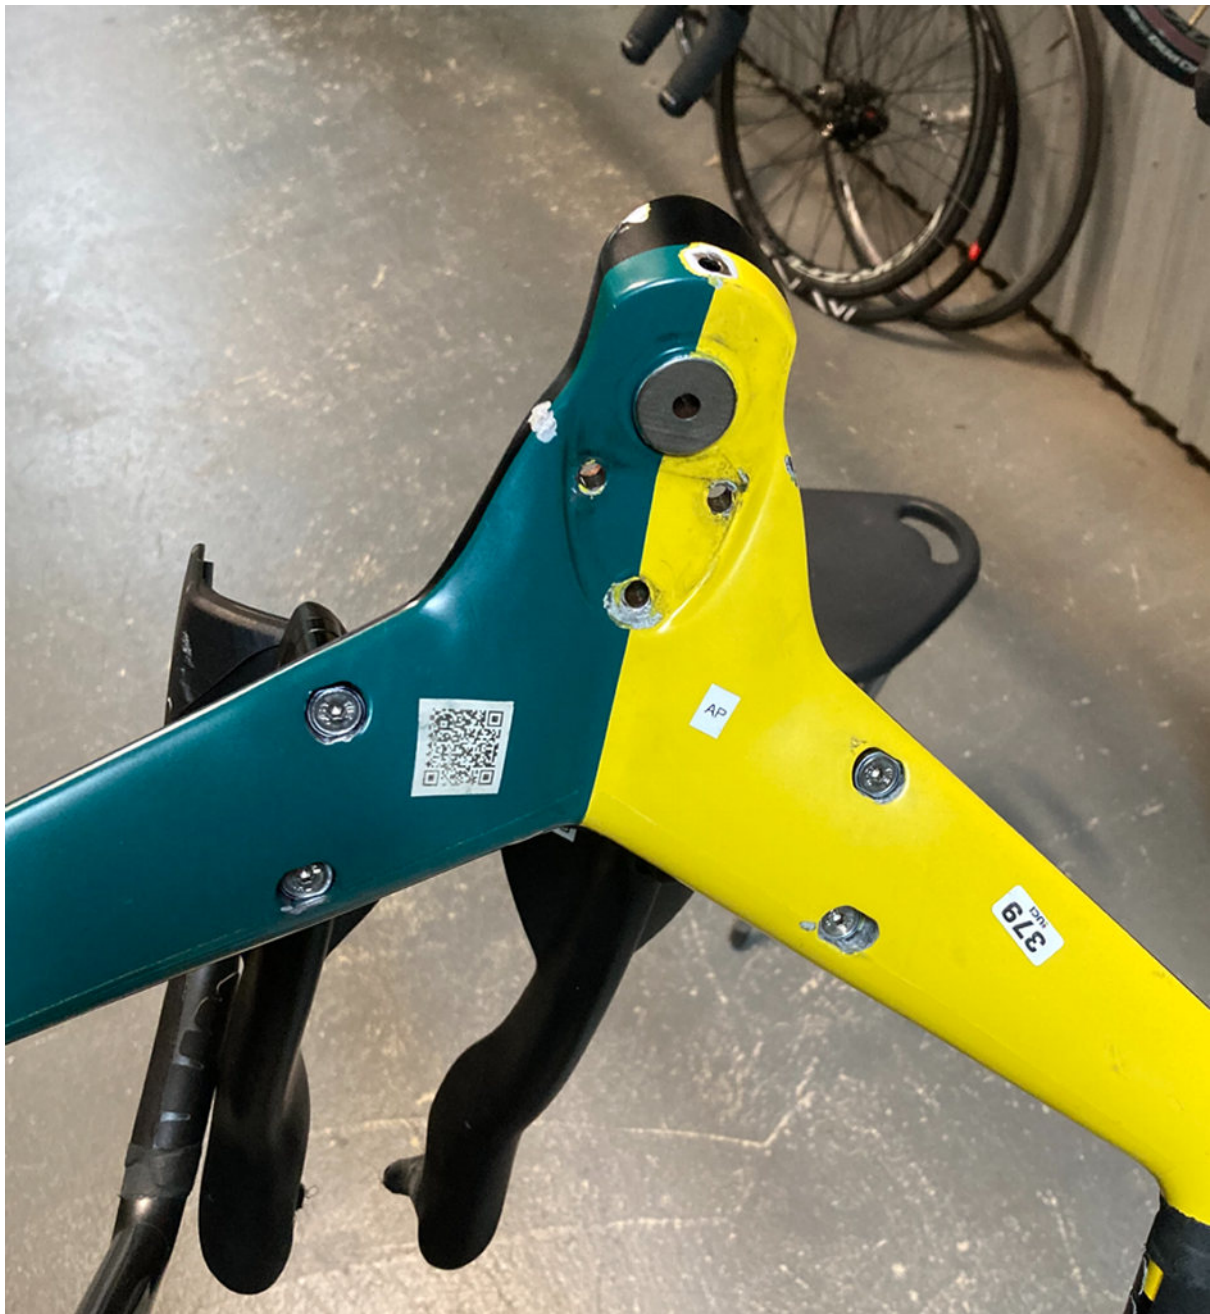
*Figure 17 - Bar #1 - original, delivered in 2019. Painted underside to match livery of standard Argon 2020 base bars. Note paint worn away at front of mounting face with fork crown. Kept as a spare and used only by AP in 2<sup>nd</sup> attempt at qualifying ride*

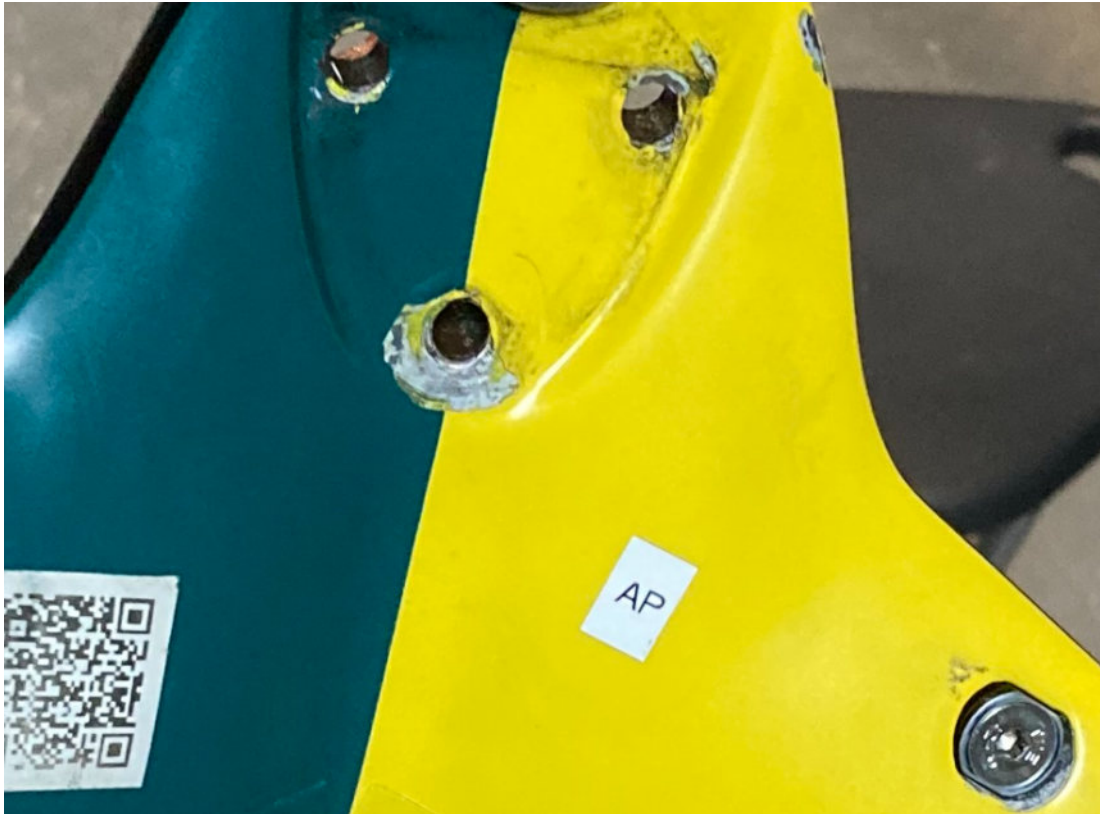
*Figure 18 - Closeup of paint worn away on bar #1*

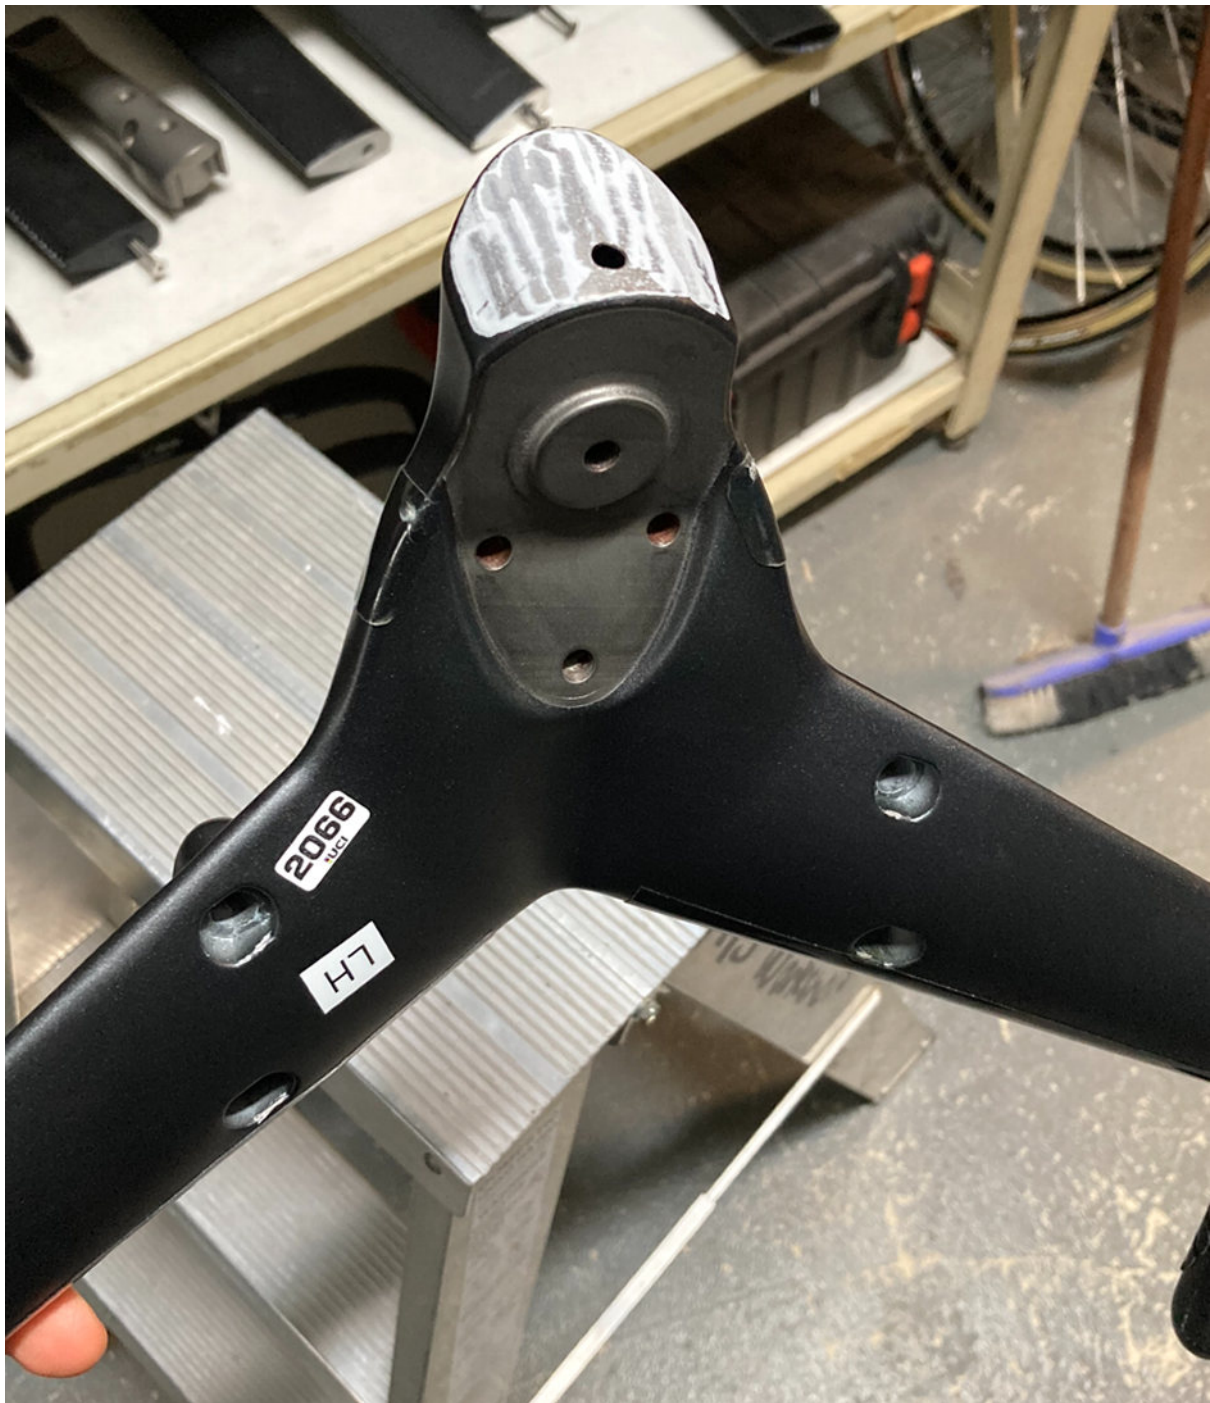
Figure 20 - Bar #2. Used by Leigh Howard in Tokyo. Note there appears to be beginning of crack forming at front of mounting face

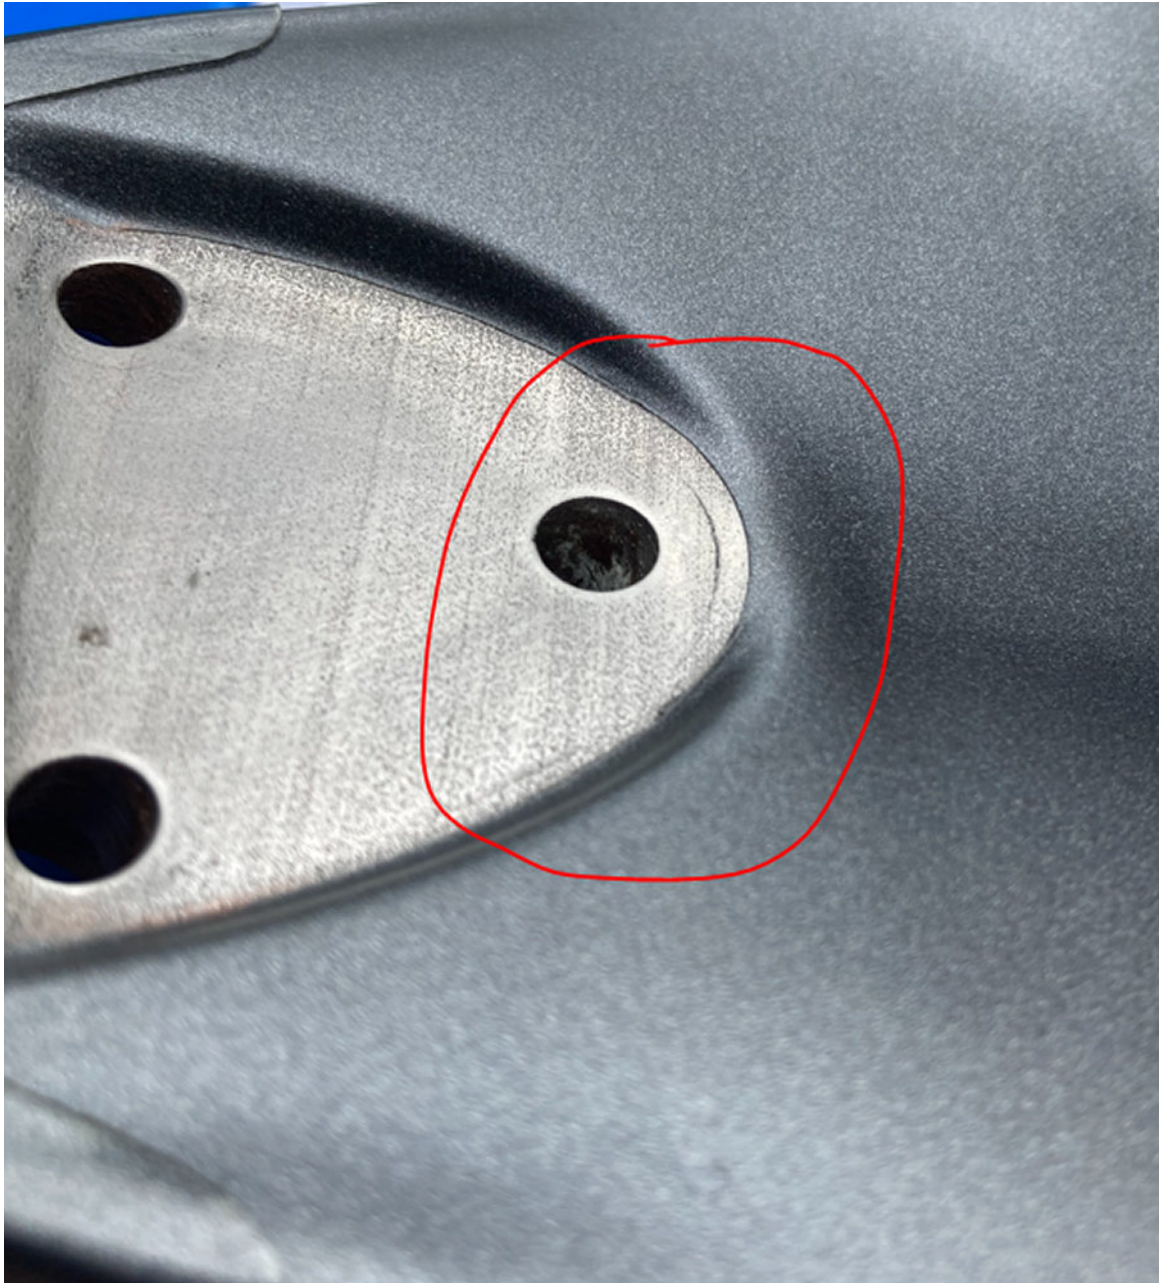
*Figure 21 - Close-up of apparent crack beginning to form on bar #2*

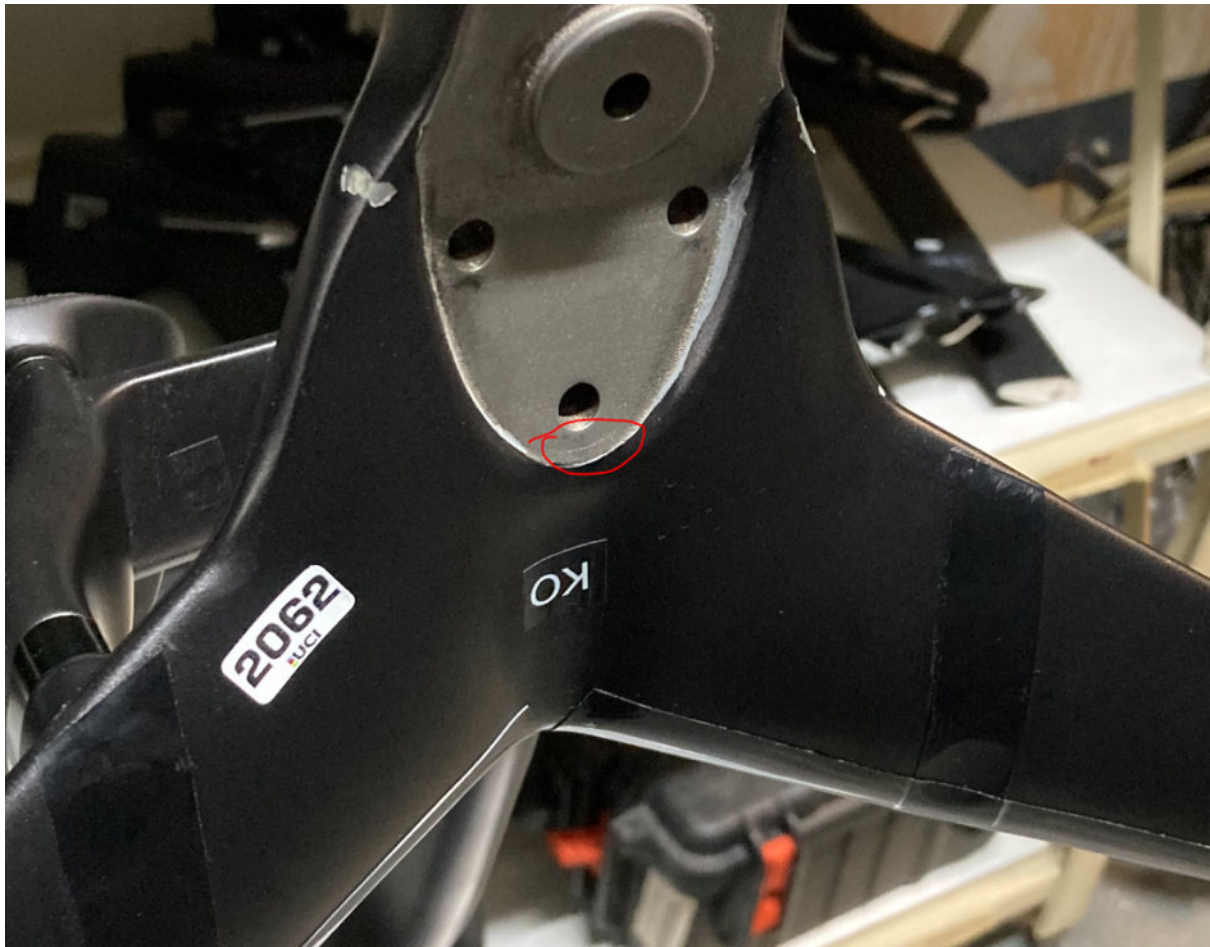
Figure 24 - Apparent crack beginning to form at same location on bar #3

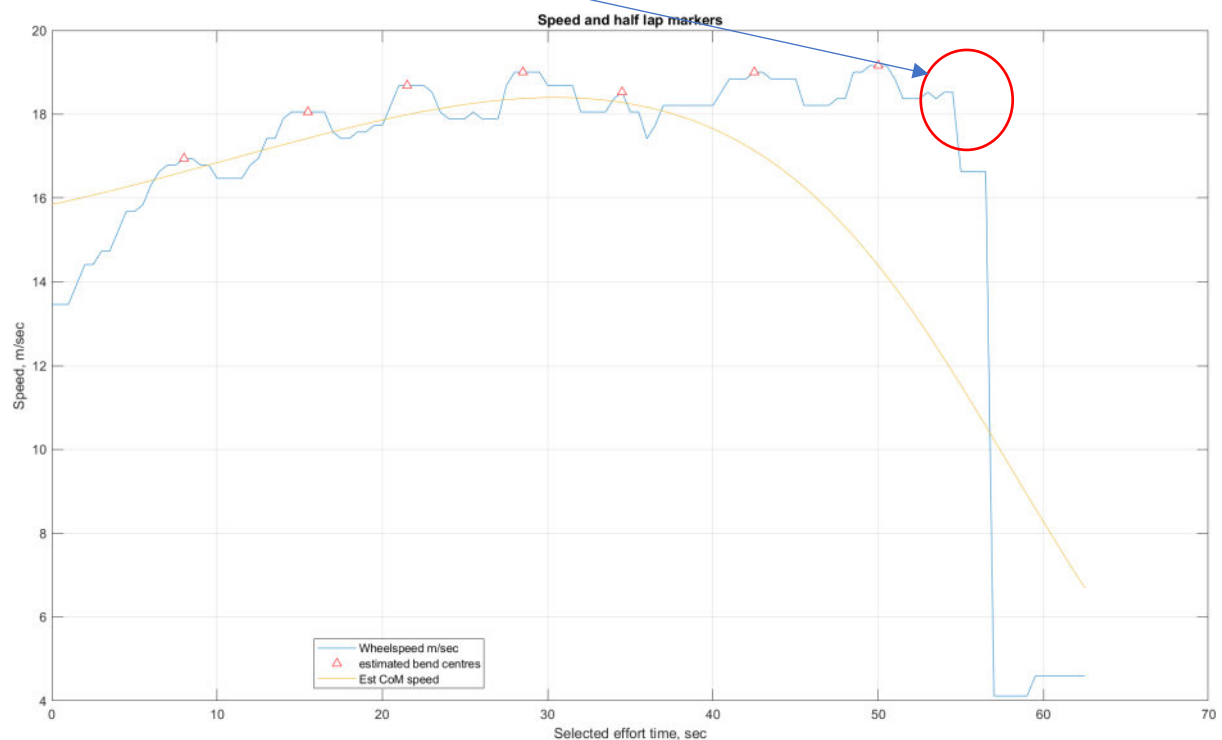
Speed at point of crash was 18.5 m/sec.

Figure 30 - Alex Porter Qualifying ride speed trace

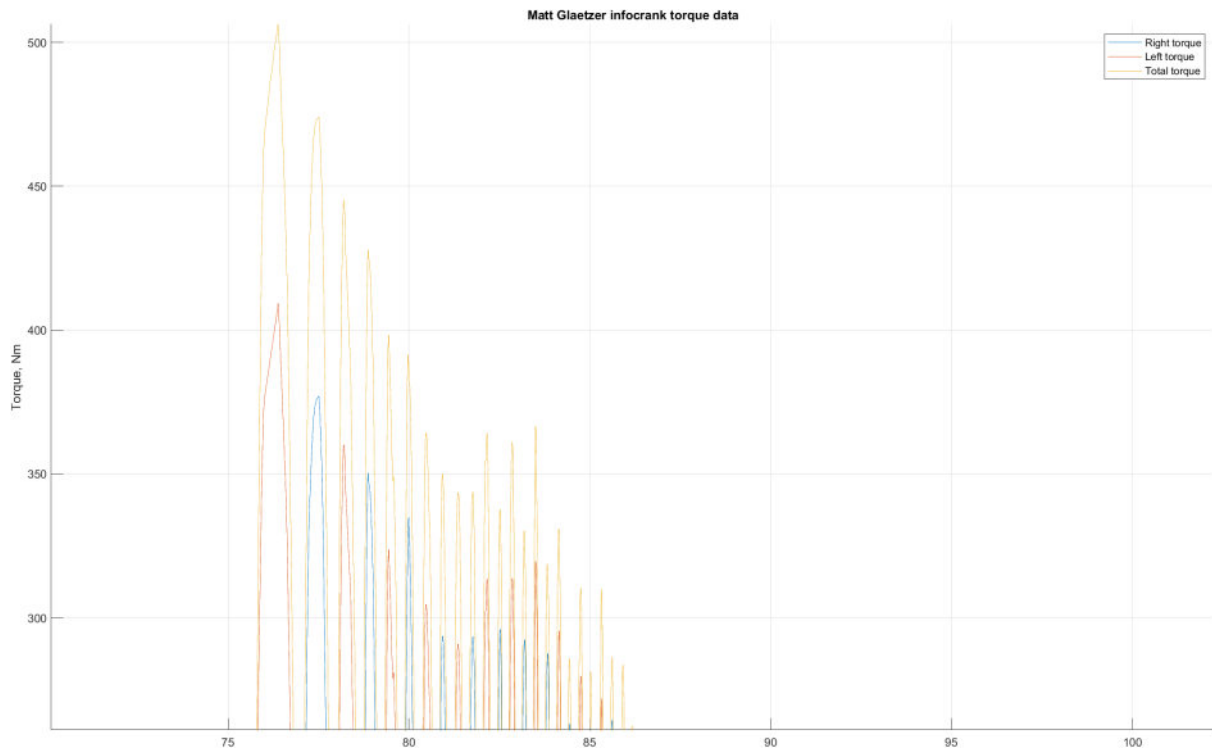
The following data is from a standing start by Matt Glaetzer, one of the ACT sprinters (who is approx. 10% heavier than Alex Porter and more powerful), using an Infocrank power meter, which records constant torque data at 196Hz. Each crank side has a separate measurement channel, which enables the torque applied through that crank to be seen.

Figure 33 - Matt Glaetzer infocrank data

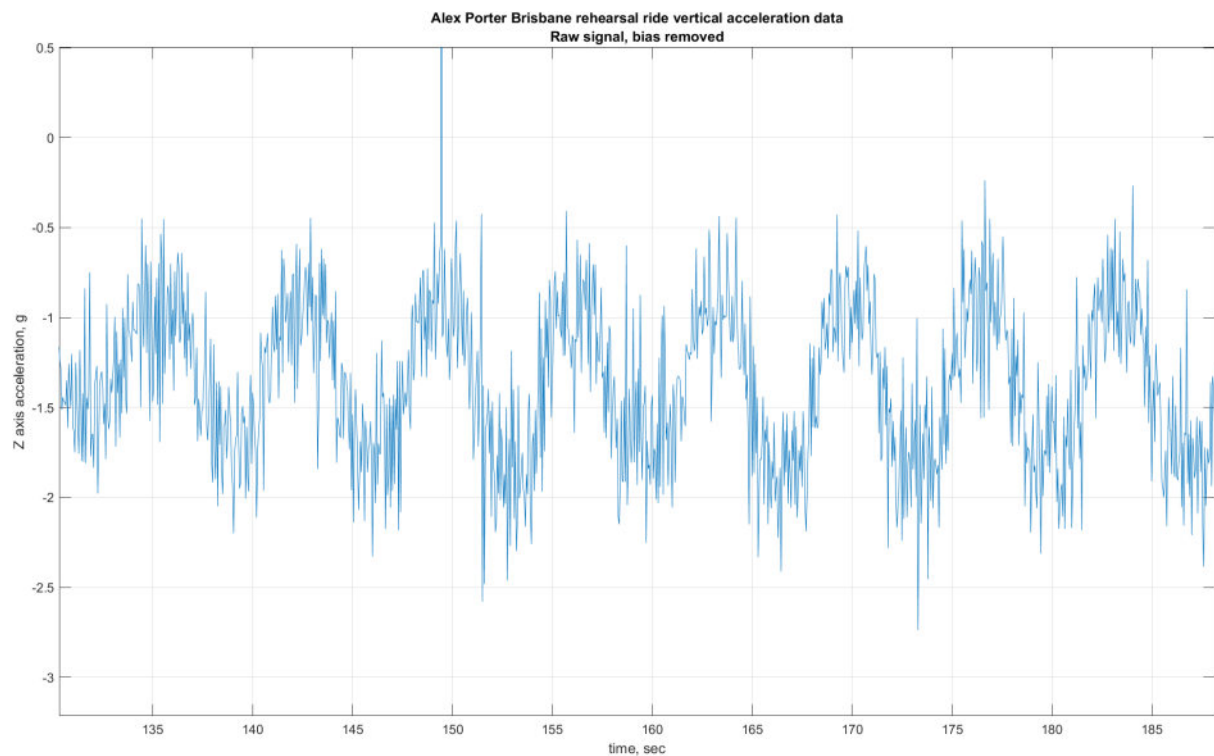
It can be seen from Figure 39 that the peak 'g' in the bends at these race speeds is approx. 1.8g.

Figure 39 - Notio Konect rehearsal z-axis acceleration data zoom-in, g
